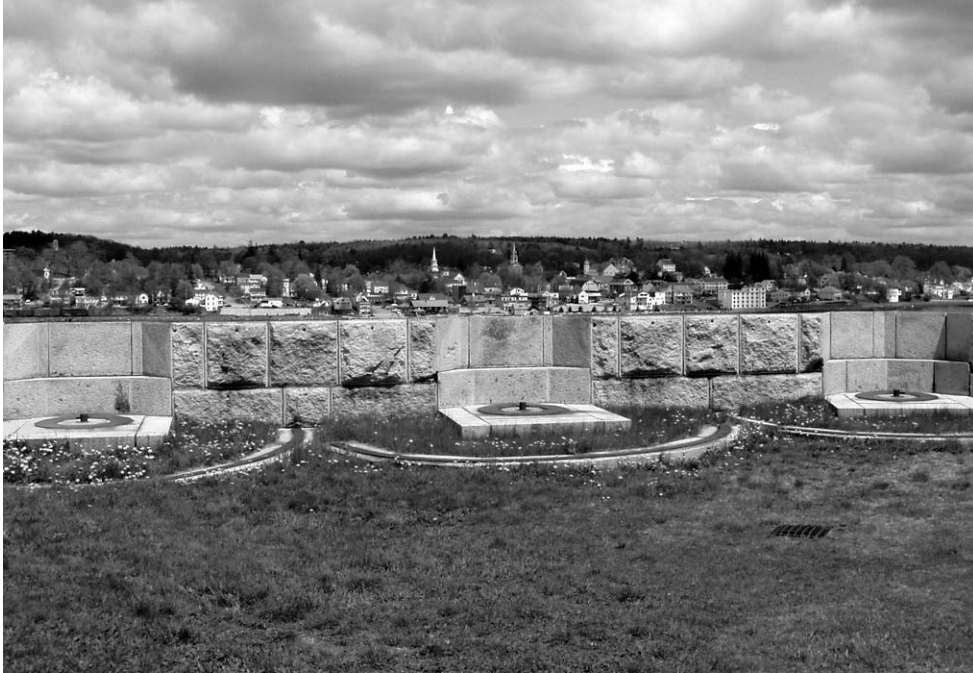
Above: Fore-pintle mounts on the barbette at Fort Knox, Maine. The barbette tiers on the curtains of Fort Montgomery would have looked very similar to this. Below: The scarp of south-facing curtain II at Ft. Montgomery. Several rows of limestone were removed from atop this wall by the demolition crews in 1936-37. Most of the barbette has been destroyed as have been the bulk of the second-tier casemates below. By design, the outward-facing scarp wall was not connected to the rest of the parapet. When the casemate tier below was demolished this wall was left free standing, with nothing behind it.
